LOWER HOUSATONIC RIVER BASIN
PLYMOUTH, CONNECTICUT

WILTON POND DAM
CT-00284

PHASE I INSPECTION REPORT
NATIONAL DAM INSPECTION PROGRAM

FEBRUARY 1980

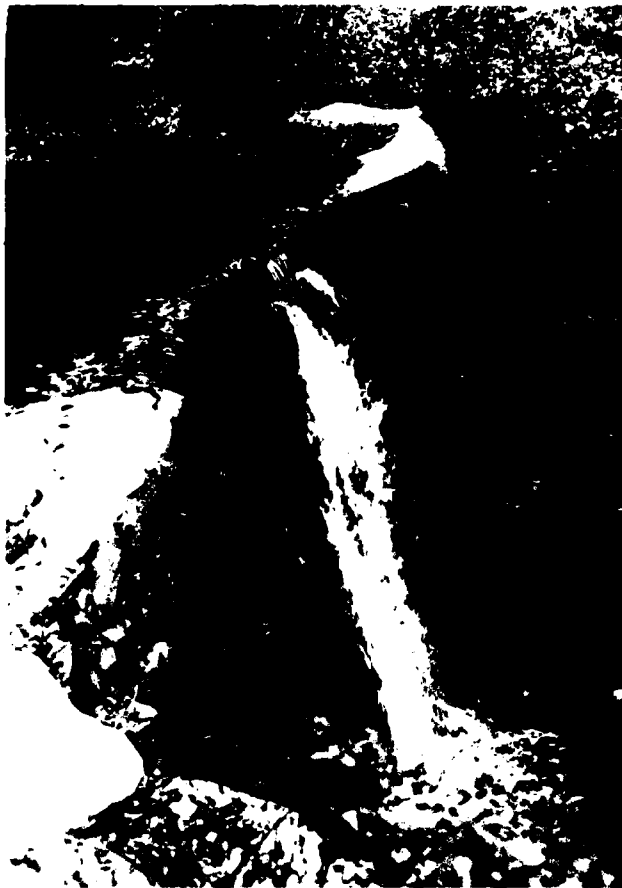
1) Spillway - Water discharges over the central portion of the stone masonry dam as indicated in Photo No. 3 and Photo No. 6. The crest of the overflow section has received a recent grout cap over the stone masonry blocks, and is in good condition. An 18 to 24 inch lip contains the spillway flow (Photo No. 4 and Photo No. 11). The Wilton Road bridge restricts flow to the dam spillway (see Photo No. 13).

PHOTO #3: Overflow section from right (west) abutment.

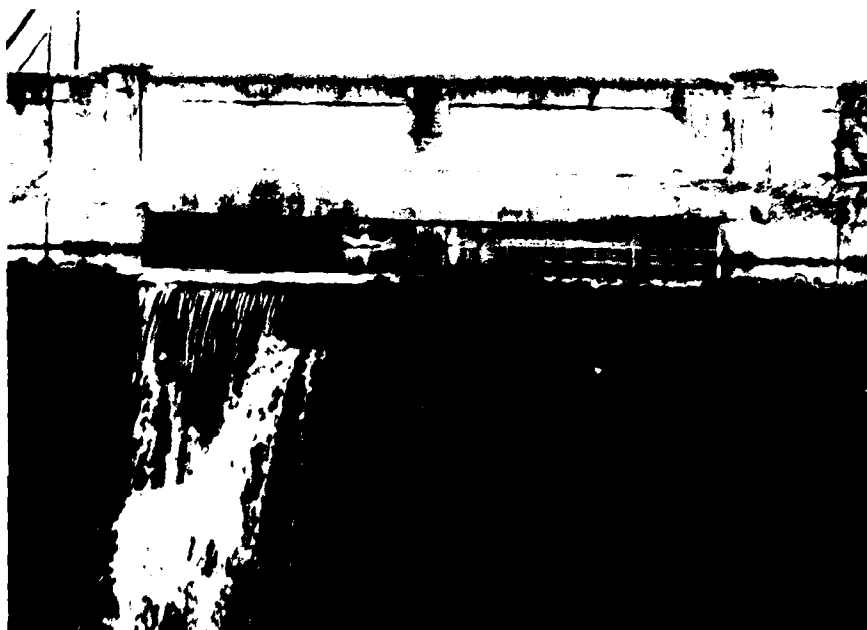
PHOTO #6: Crest of dam, looking toward Wilton Pond.

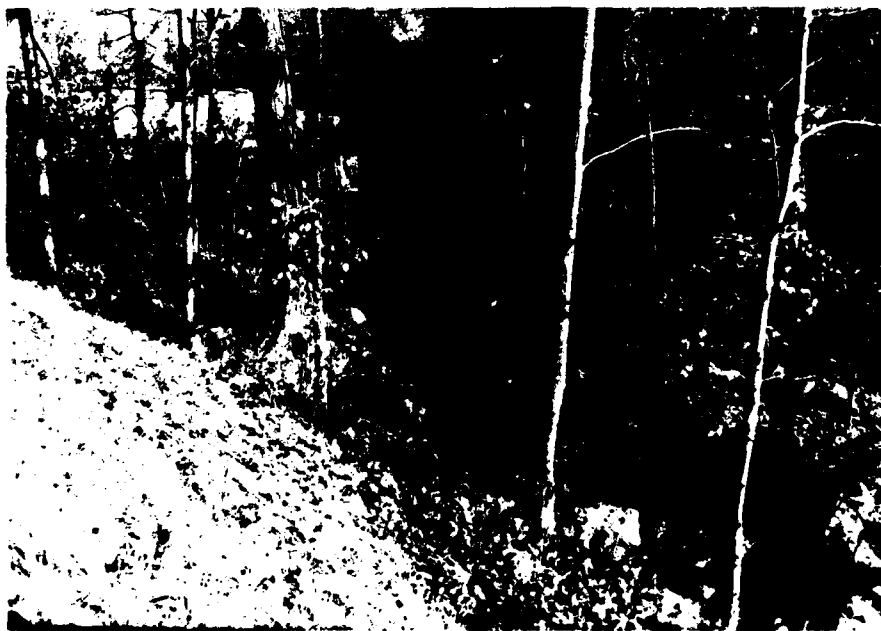
PHOTO #12: Looking upstream along spillway channel.
